**205/23 Town Hall – Quinquennial Inspection Report – attached**

**QUINQUENNIAL INSPECTION REPORT**  
with Recommendations for Repair

**BRACKLEY TOWN HALL**

First Quinquennial Inspection  
For Brackley Town Council

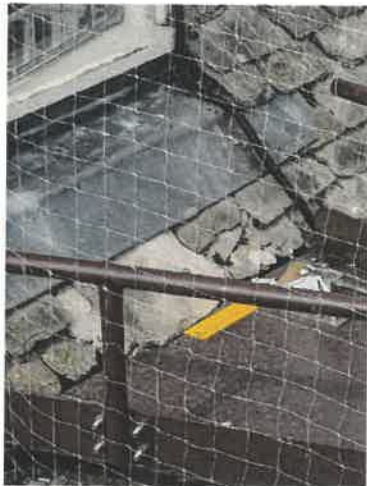
- 3.11 On the N side of the roof below the dormer lead apron a number of damaged slates above the gantry leading to the flagpole can be seen. The lead clip to the lead apron is also disturbed; photo 1. The cause is foot traffic when accessing the flagpole. The slates need to be repaired. A longer term solution would be to replace the slates with another piece of lead apron. This would need to be carefully detailed and executed in order to retain the roof ventilation detail.
- 3.12 The lead in the valley either side of the pediment is beginning to be affected by acid run off from the moss colonising the roof; photo 2. This is not significant at present as the lead is quite thick. The areas should be monitored. It would be helpful if the moss was carefully brushed off the slates above the valley during regular gutter clearance to limit this process.

1. Damaged slates below the N dormer above flagpole gantry

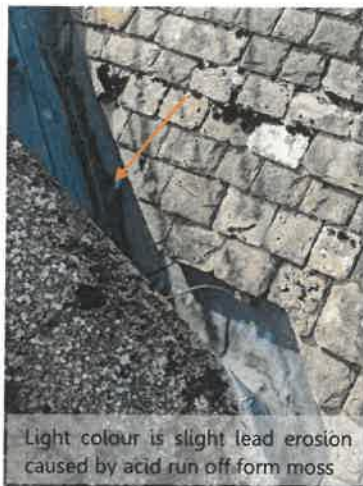
2. Lead valley to W side of N pediment

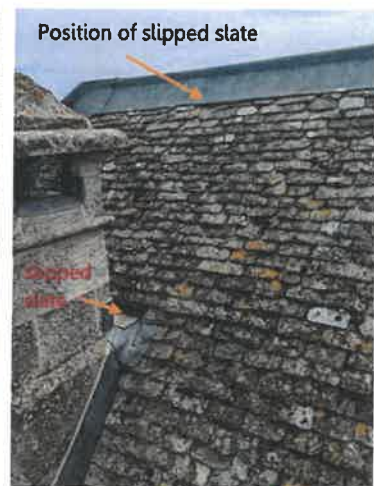
- 3.13 A small slate beneath the lead covered ridge was missing. It had slipped and was retrieved from the lead gutter behind the stone chimney stack; photo 3. This needs to be refixed to weather the roof and prevent the gap being colonised by wildlife.
- 3.14 Another slipped tile to the side of the lead covered pier above the second dormer was wedged temporarily during the inspection with a lead offcut picked up from the dormer roof; photos 4 and 5. It needs to be firmly secured.

3. W roof slope

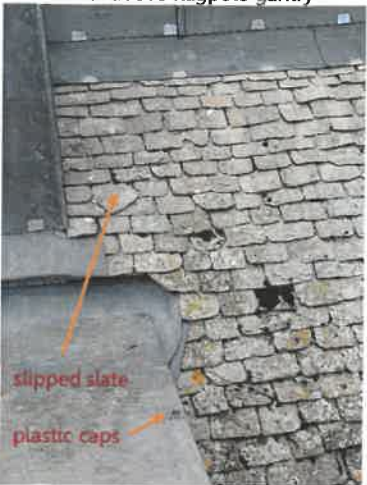
4. W roof slope

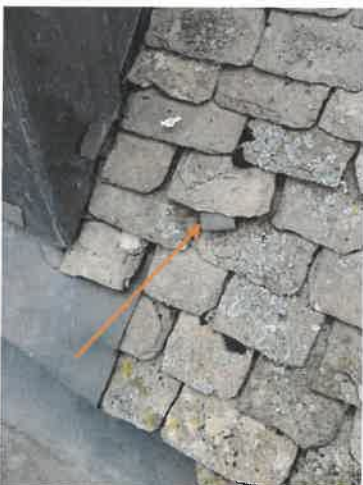
5. Slate temporarily wedged

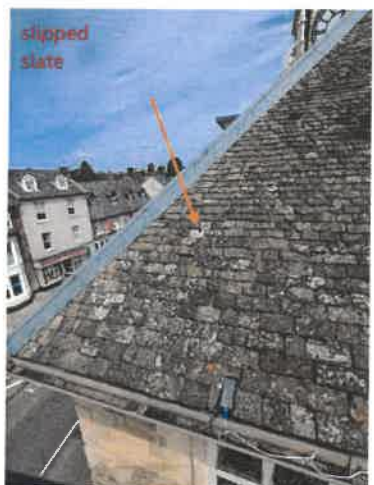
- 3.15 A missing slate was noted at low level on the W side. This was temporarily replaced during the inspection but a replacement with a matching stone slate is needed. There is a slipped slate higher up below the lead hip roll, also on the W side, which needs to be secured; photos 6 and 7.
- 3.16 Another slate is missing from beneath the dormer apron and this to be replaced; photo 8.

6. S slope- Missing slate temporarily replaced

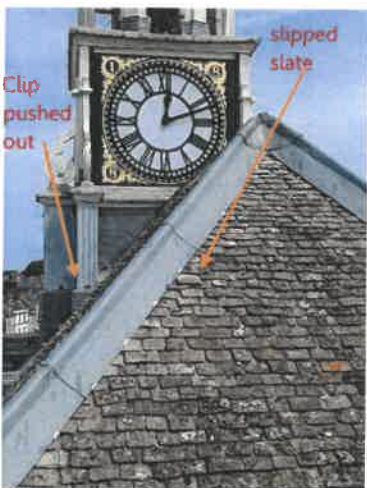
- 3.21 Disturbed lead clips can also be seen in other locations around the cupola, such as the base of the triangular lead sheets on the S side; photo 7. The clips should be readjusted throughout to allow a gap of 4-5mm between the fold and the edge of the sheet. At the same time a few missing tacks to the dog tooth detailing should be replaced.

7. S slope and S Clock Turret face

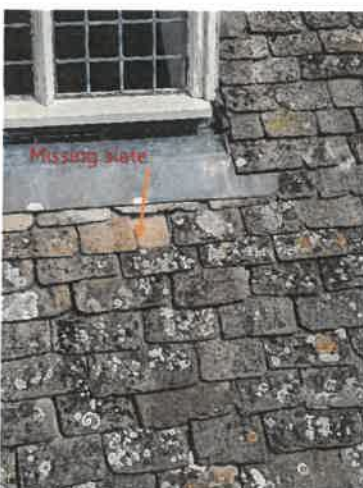
8. S slope

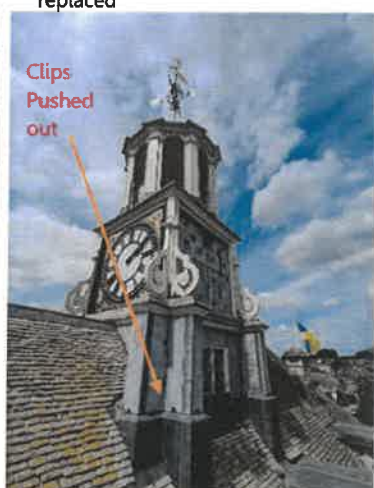
- 3.20 The historic lead cladding to the plinths with a fluting at the front and a dog tooth detail down the side was repaired. These elements are generally in good order except for the loosening of the lead clips at the bottom of the cladding in many areas around the base. This is due to the clips being turned too tight against the main lead sheet without any space for the lead sheet to expand; photo 9.

9. Clock Turret from the SE

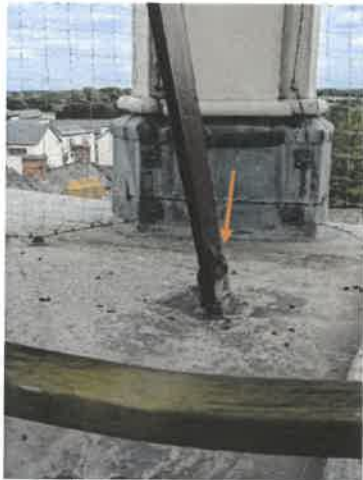
- 3.33 The bells are supported on metal frames fixed to the cupola posts and also on the timber floor of the cupola below. In the latter case the base of the frames is protected with lead sleeves. Rust is emerging at the base of one metal frame above the sleeve; photo 10. It needs to be treated and redecorated.

10. Clock Cupola Floor – Bell support rusting

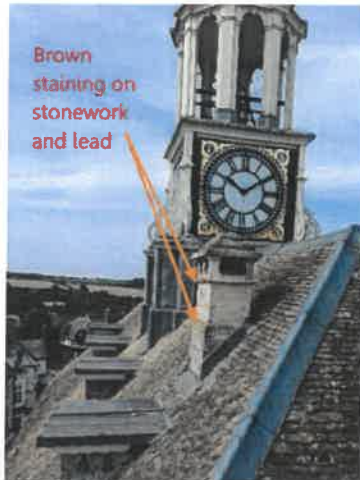
- 3.34 The lead on the floor of the cupola appeared in good condition.
- Other High Level Elements**
- 3.35 It was not possible to examine the chimney stacks in detail from the hydraulic hoist. The stonework appeared sound. A brown staining noted on the stonework of the E stack is most likely caused by boiler flue condensate, which can be acidic and corrosive; photo 11.

11. East Chimney stack

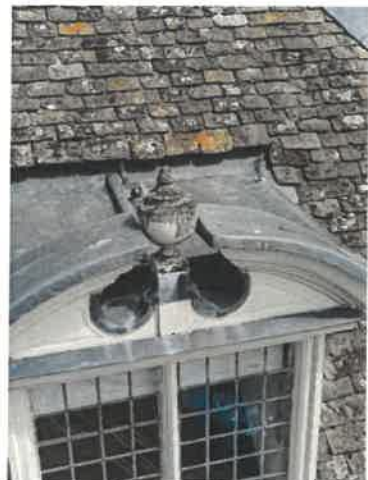
- 3.46 The decorations to the new timber urns between the pediment scrolls have failed completely on both the N and S dormers and redecoration is needed soon; photo 12

12. N Dorner- new urn completely bare

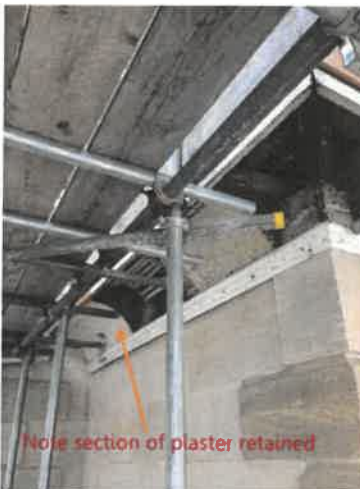
- 5.6 The stonework and pointing is good condition and the repairs 2017 are performing well.
- 5.7 A vertical crack is opening up in the lath and plaster coving to the W side of the pediment, and a small area of blown plaster can be seen close to the pediment. Photographs taken during construction show that most of this section of coving was replastered. The vertical crack may be at the junction between the retained and new section of plaster; photo 14.

14. The W side of the N covering during the repair project; see also photo 31

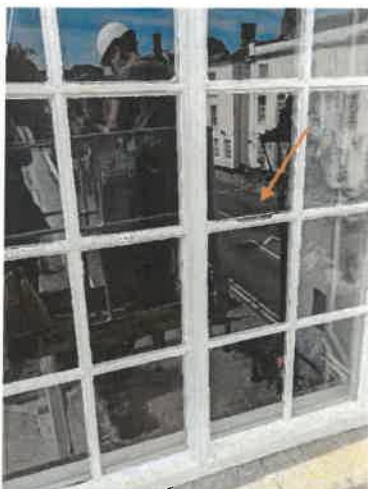
- 5.9 The putty in the centre of the lower two lights on the first floor window is missing; photo 15. The paint decorations are failing on the cill and on the metal framed centrally pivoted opening light. A slight crack is emerging between the timber frame and stone reveal which should be filled during redecoration.

15. N window with missing putty to glass

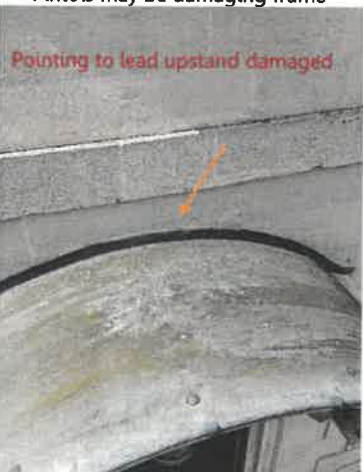
- 5.10 The pointing to the lead upstand detail on top of the canopy is cracked and missing in a few sections; photo 16. It needs to be raked out fully, the lead re-wedged if necessary and the joint repointed.

16. Lead cover to entrance canopy

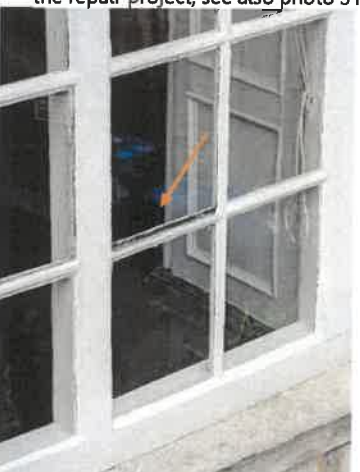
17. W side window with missing putty to glass

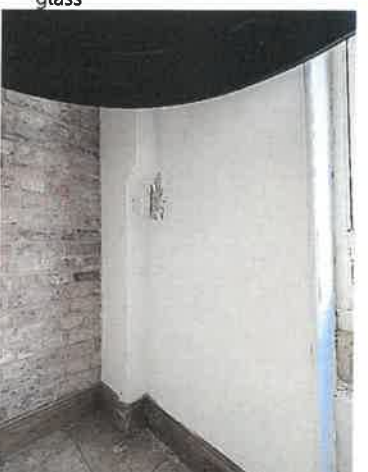
18. Damaged plaster W side below stair

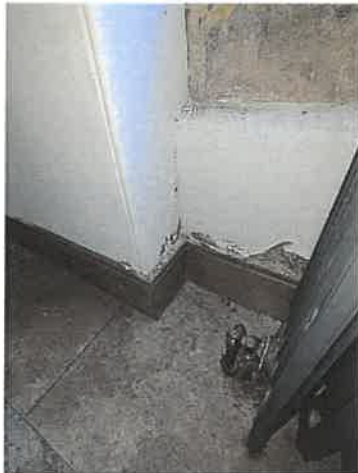
19. Damaged plaster W side below stair

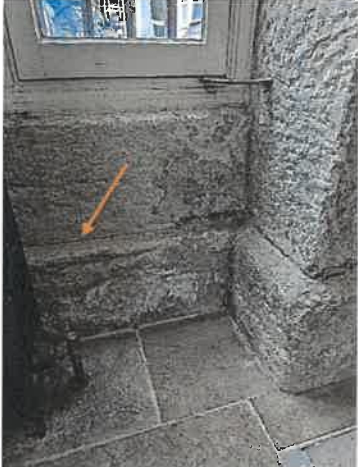
22. W window in Community Area- Salt efflorescence at low level and powdering on top of plinth

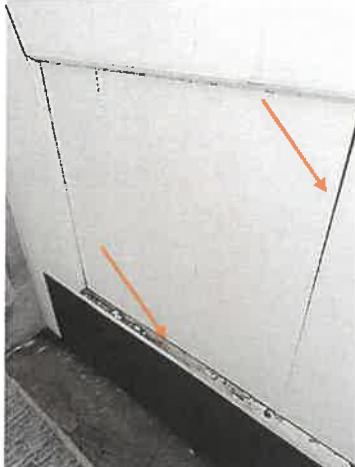
23. E door on S side; open joint and possibly water ingress staining

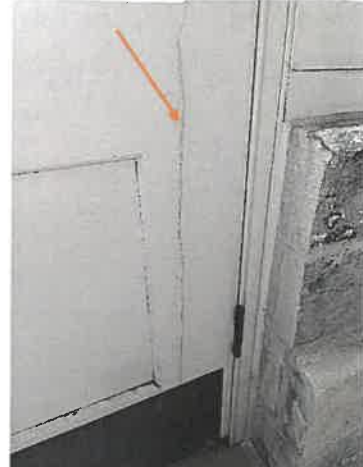
24. W door on S side; possible water ingress through gunstock joint.

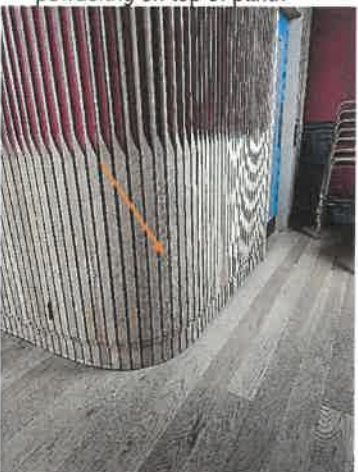
25. Slight white bloom on pod timbers on first floor

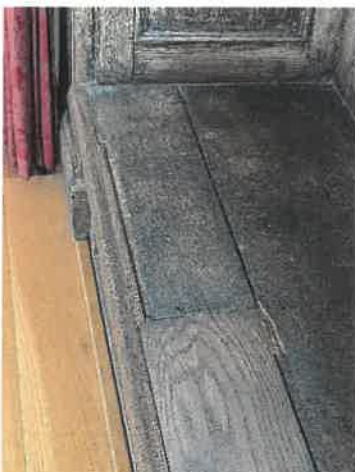
26. Damaged window seat on first floor E side.

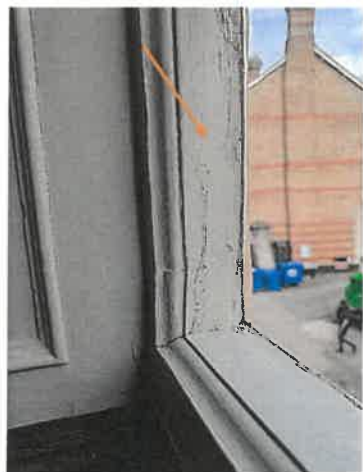
27. E window on first floor; possible water ingress through defective putty

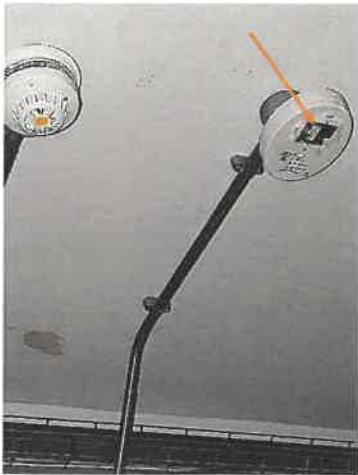
7.49 On the E side of the stair landing the boiler room is set above the kitchen area on the floor below. Separate boilers serve the flat and the remaining building. A small cover to the Carbon monoxide monitor wiring is missing and should be re replaced; photo 28.

28. Missing cover to carbon monoxide sensor in boiler room

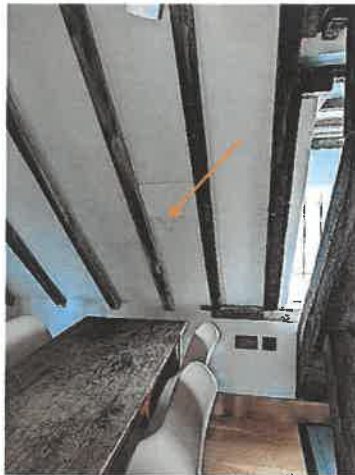
29. Staining below access panel in attic flat

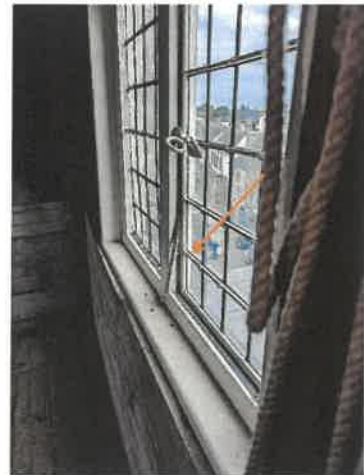
30. E window to pendulum room; defective seal and frame not engaging correctly

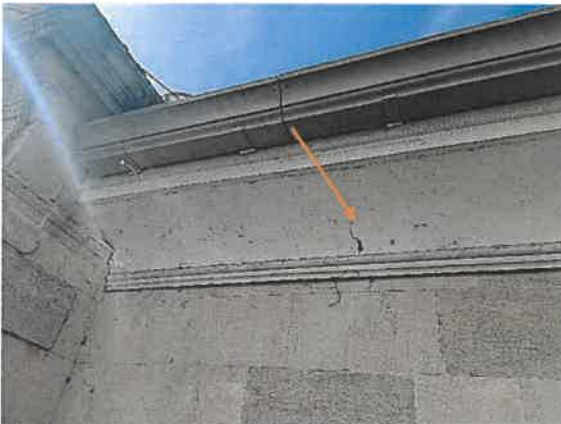
- 5.8 On the opposite side there is a horizontal crack at the base of the coving; photo 31. The entire coving on this N elevation needs to be checked for soundness and repairs made. This should be carried out by a mason/plasterer experienced in the use of lime mortars using the same mix as the 2017 repair.

31. W side of coving on N side; vertical crack opening up. See also photo 14.

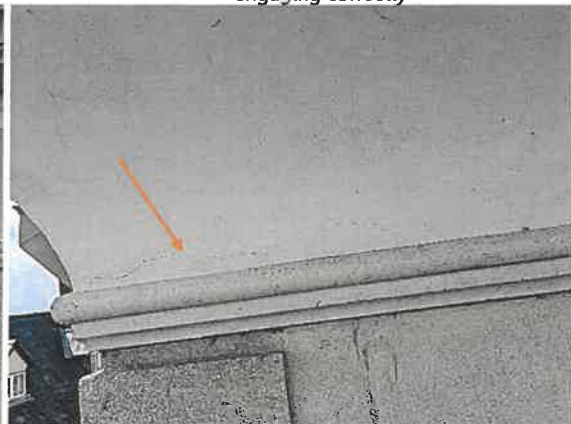
32. E side of coving- Slight horizontal crack at the base.
