**205/23 Town Hall – Quinquennial Inspection Report – attached**

**QUINQUENNIAL INSPECTION REPORT**  
with Recommendations for Repair

**BRACKLEY TOWN HALL**

First Quinquennial Inspection  
For Brackley Town Council

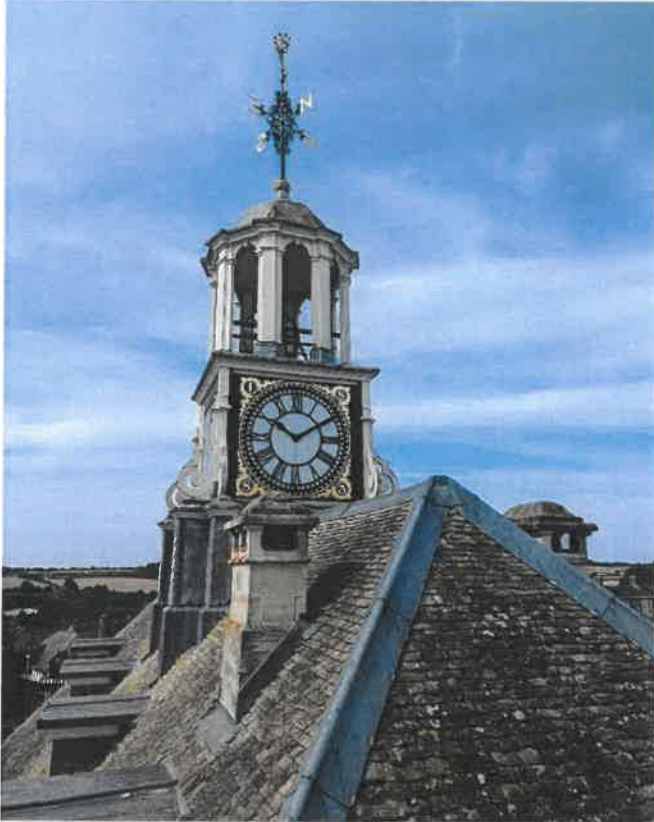
Fig. 4. The Clock Turret from the north

- 3.23 The Clock stage of the Turret is framed at the corners by tall, scrolled timber brackets supported from the angled plinths at the four corners. I suspect these were replaced at some time in the 20<sup>th</sup> century before the 2017 repairs. The timberwork is in good condition but all the brackets support algae and need to be cleaned and redecorated.

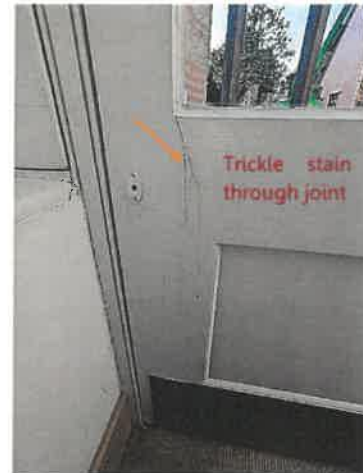
21. Fire escape door to office
